Survey of the submerged ordnance at Camel Rock and

War in the Pacific NHP, Guam

Conducted by

Natural Resources Division War in the Pacific NHP Asan, Guam

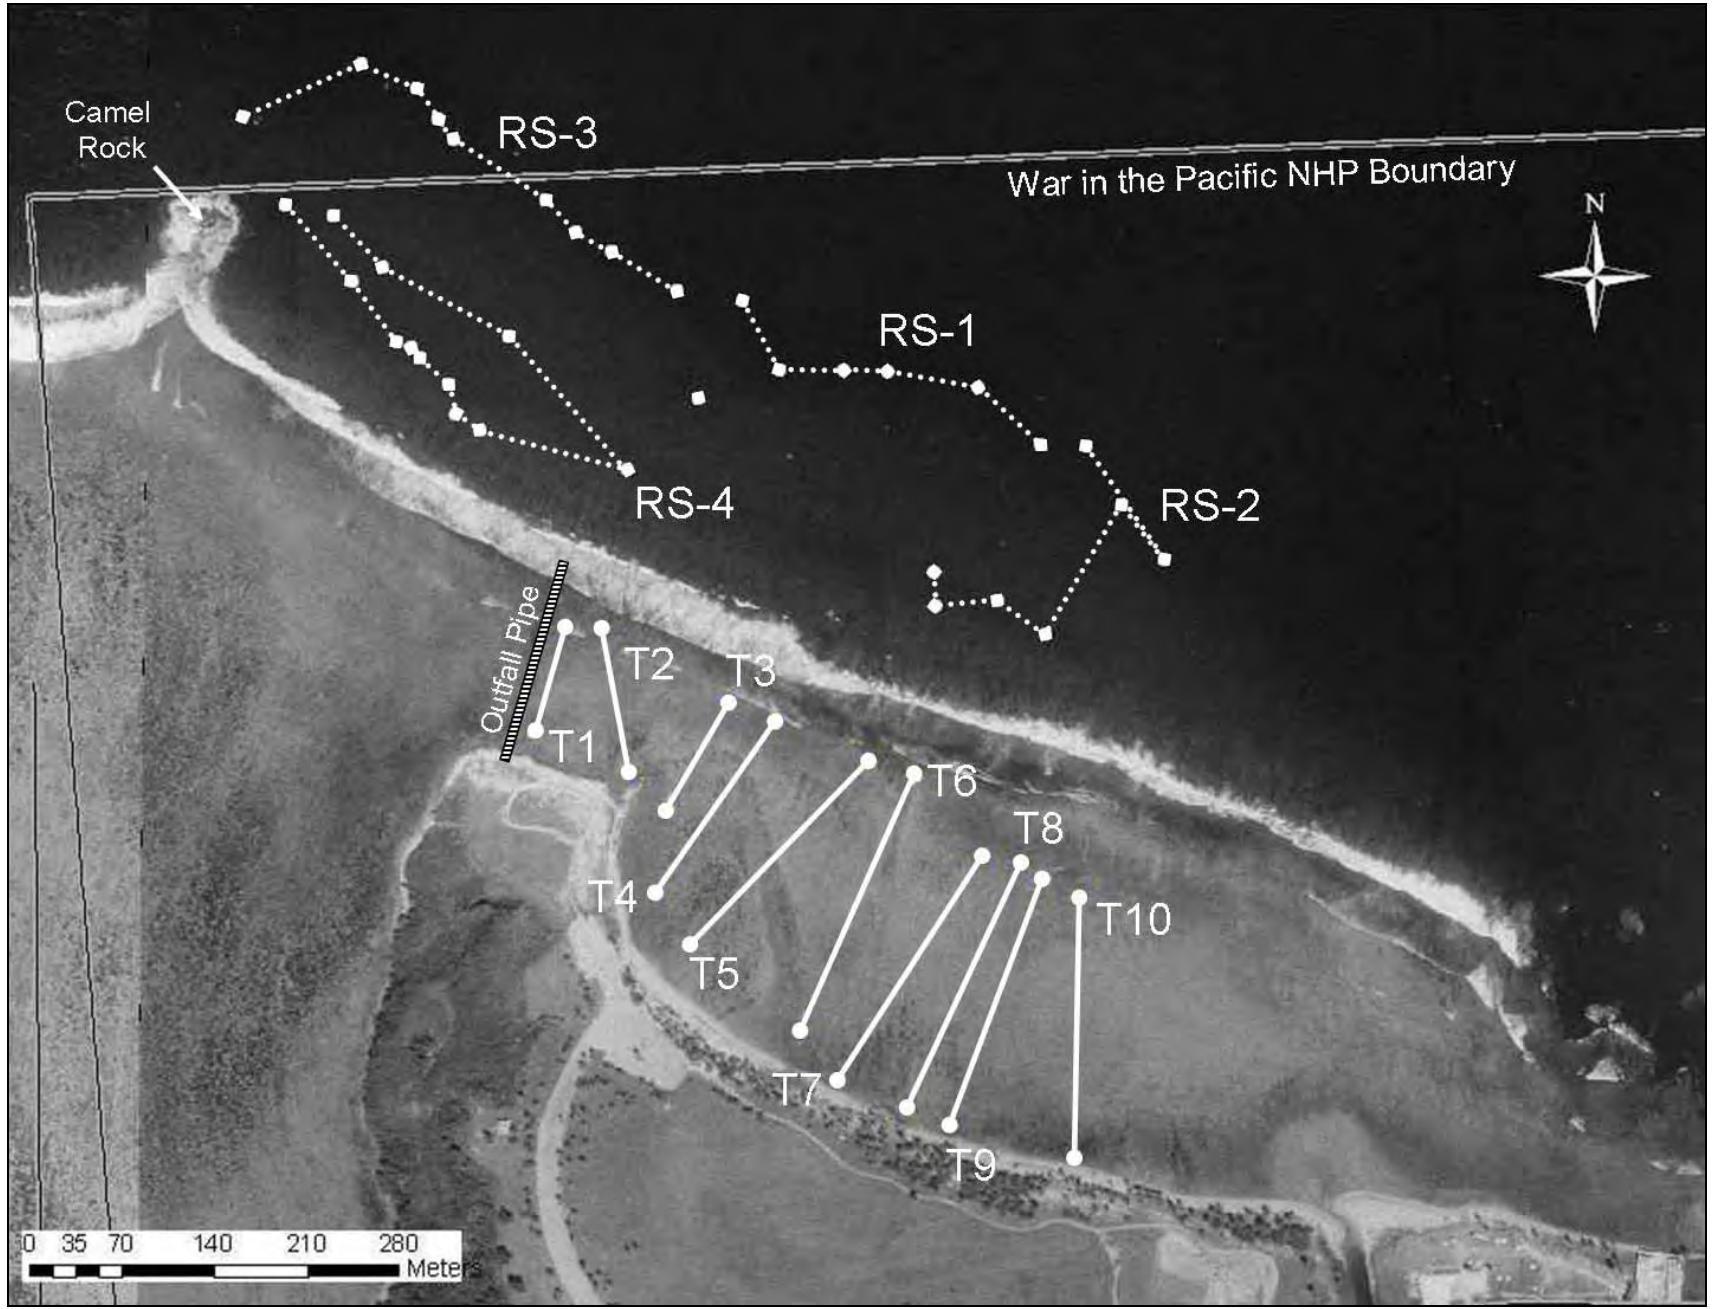
Figure 1. Location of reef flat transects and reef slope survey lines.

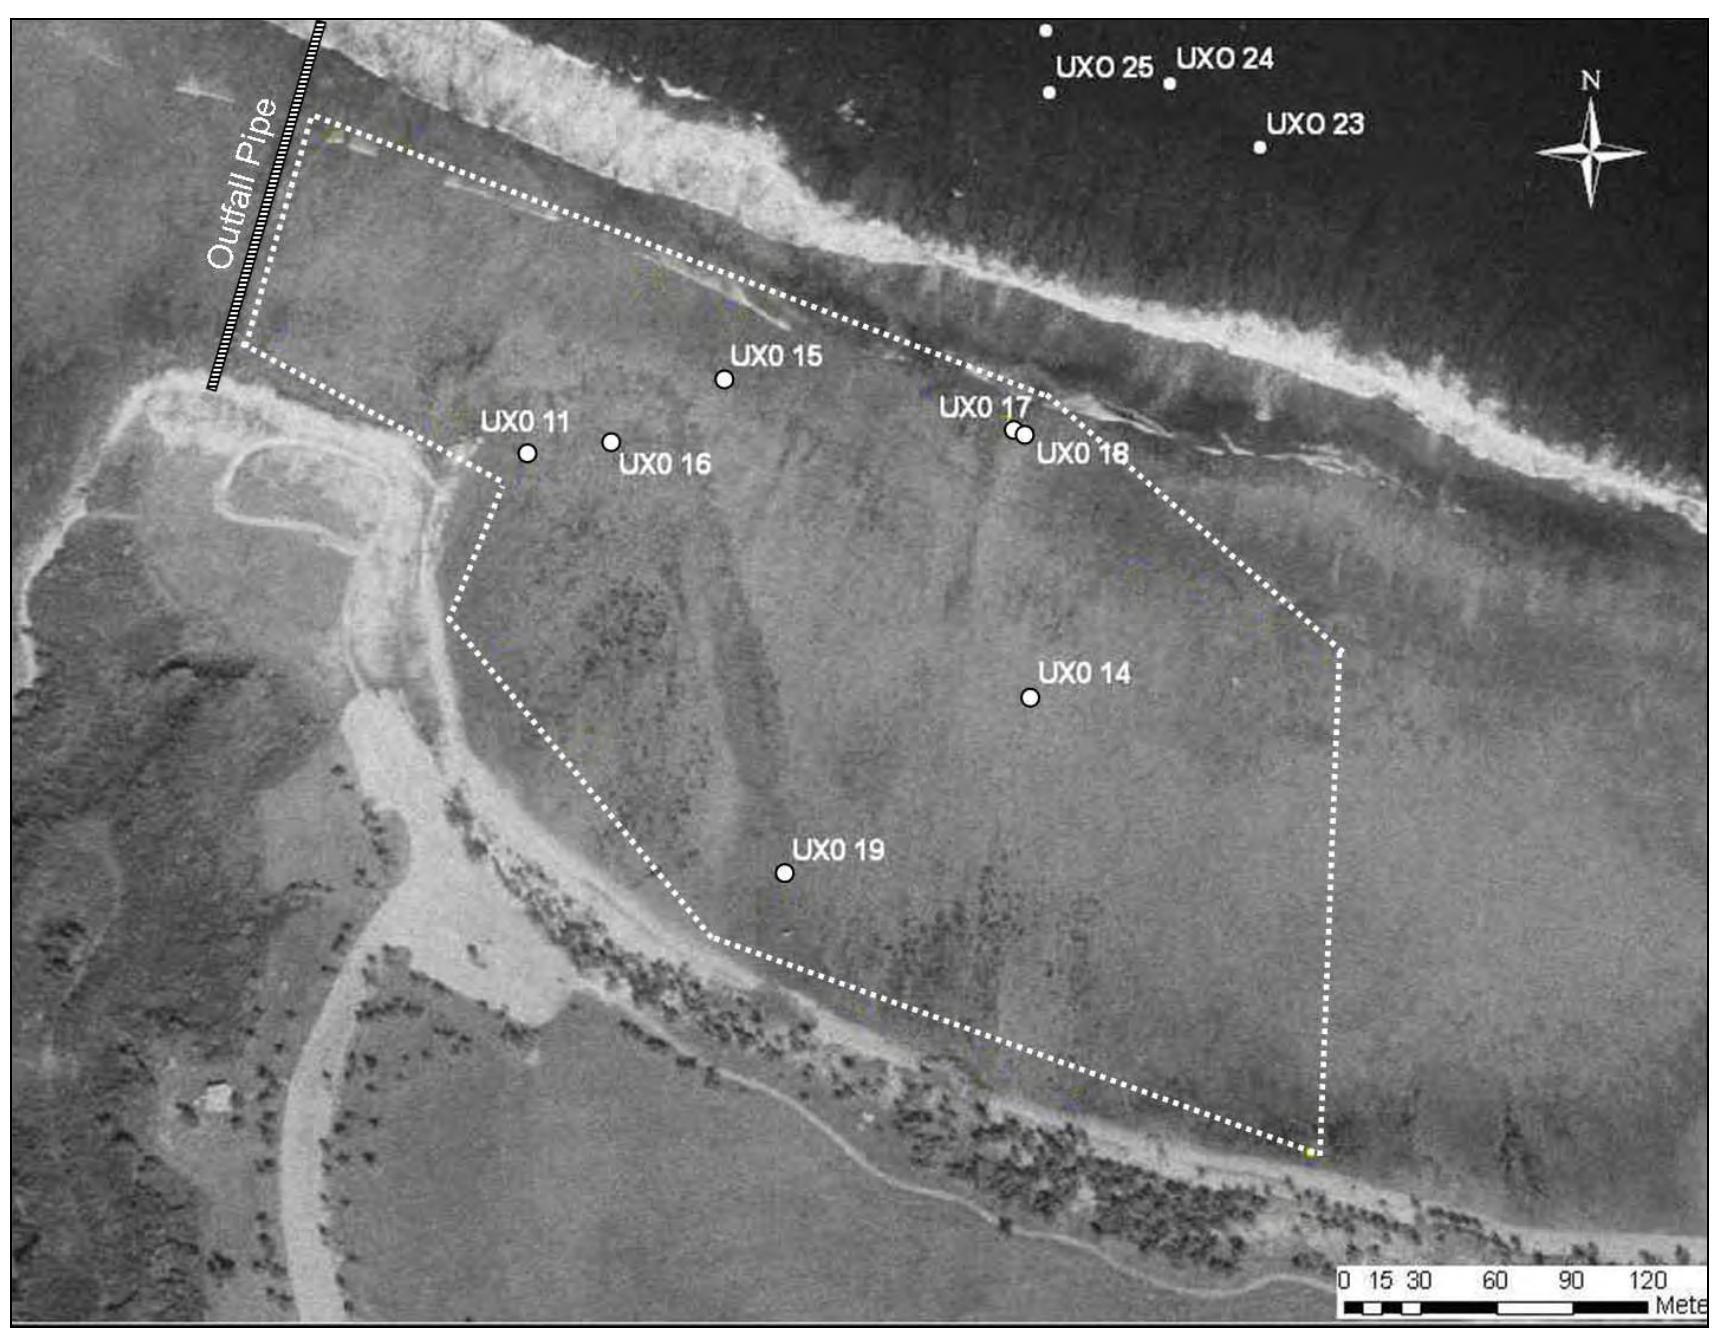
On the reef flat, ordnance tended to occur closer to the reef crest (Figure 2), however, a small concentration of ordnance was located at site UXO 19, which is near shore and in or near the designated swimming area for War in the Pacific NHP. The ordnance found on the reef flat during this survey was exclusively small arms ammunition, but larger ordnance have been found on the reef flat on at least one occasion. The EPA located a large shell near the outfall pipe in August 2005. Based on the photograph, taken at low tide, the position of the ordnance is just to the east of the outfall pipe nearer to the reef crest than to the shore. Attempts to relocate this specific ordnance during this survey were unsuccessful.

Figure 2. Locations of UXO found on the reef flat at War in the Pacific NHP. Dotted line marks the approximate perimeter of the reef flat search area.

Due to time limitations and ocean conditions two areas did not receive adequate inspection. The reef flat to the west of the old outfall pipe was not surveyed, and its proximity to a high concentrations of ordnance just over the reef crest suggest it is a likely site at which to find migrating ordnance. Additionally, the shallow fore reef near the reef crest to the east of the outfall pipe was not adequately surveyed and should receive more attention in the future

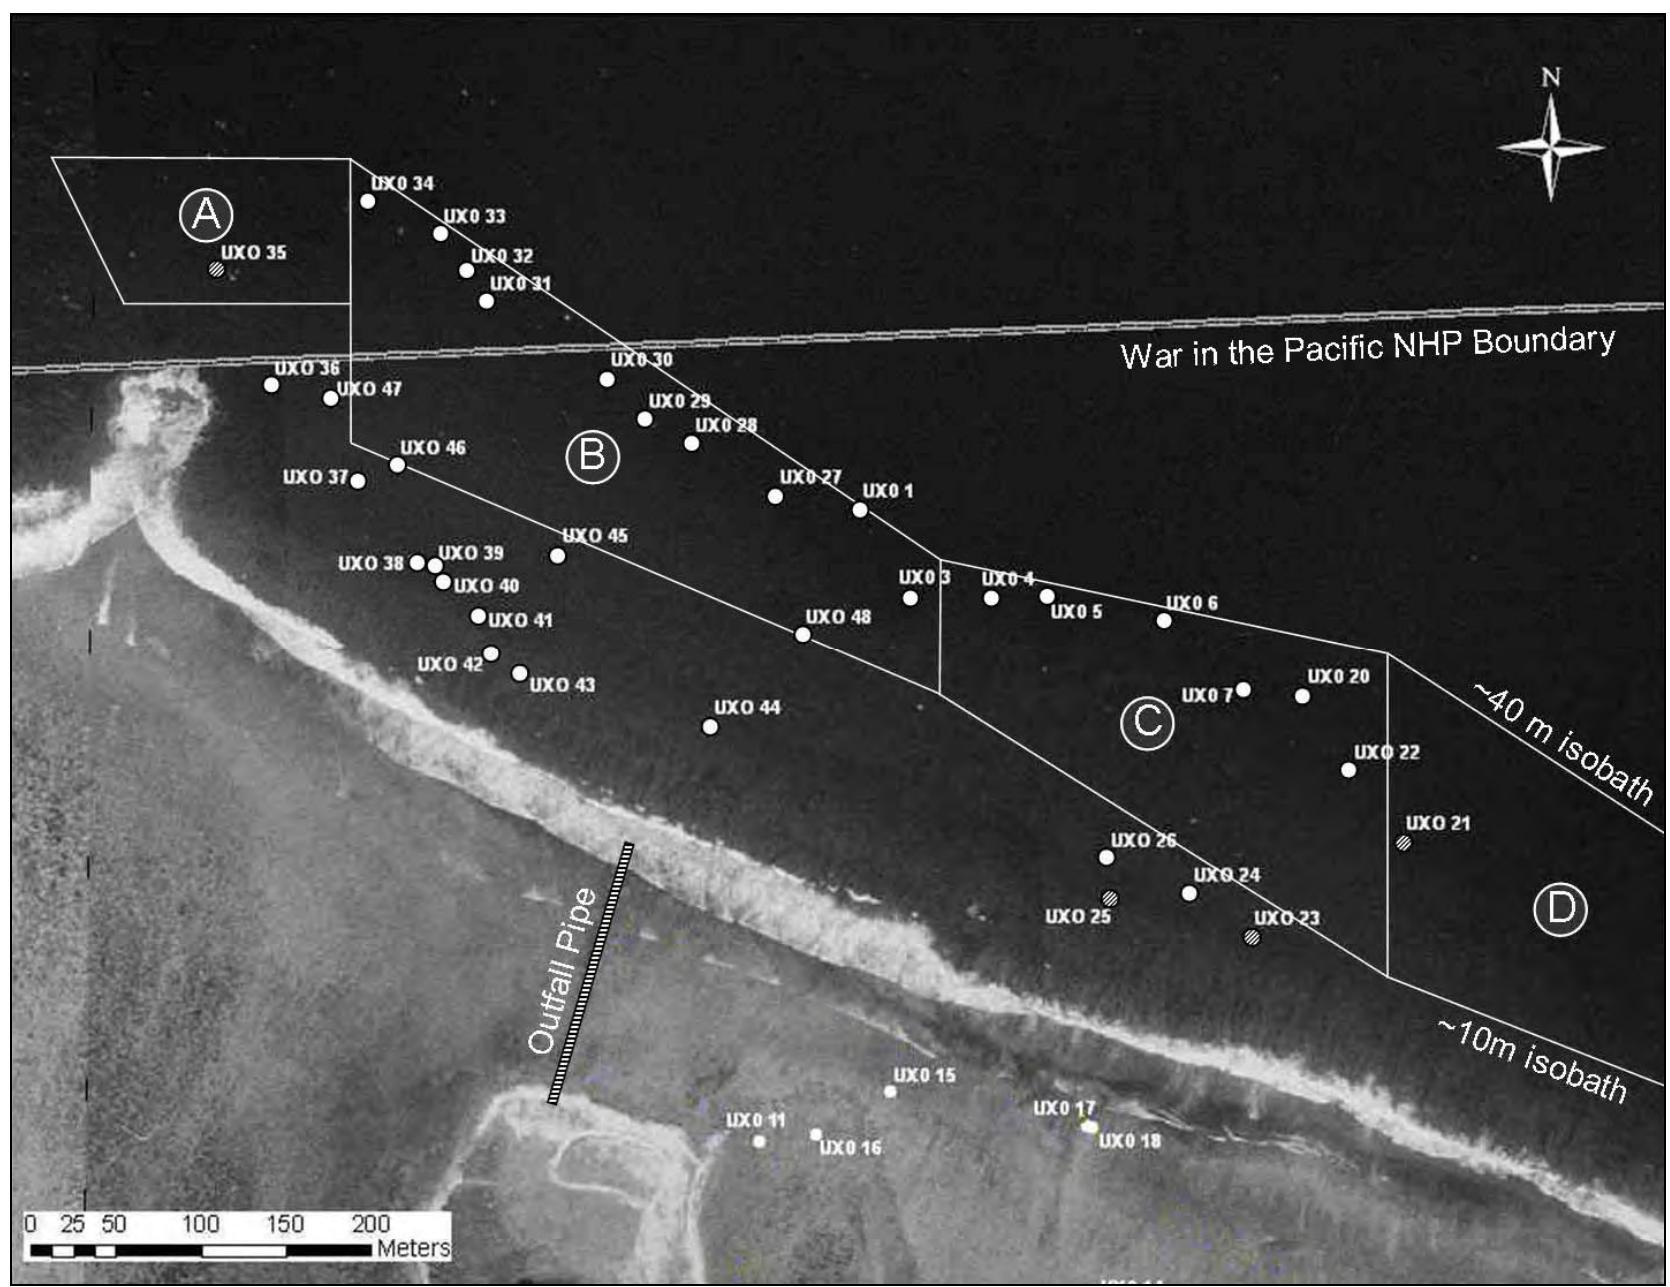
On the reef slope (Figure 3), ordnance were observed deeper than 40 meters at two locations, UXO 1 and UXO 20. Ordnance were found at high concentrations in shallow water (UXO 38-44). The shallow (<6 m) fore reef in this area is limestone pavement incised with 1 meter crevices running approximately perpendicular to the reef crest. In nearly every crevice in this area, at least one large ordnance was found, and, in many instances, numerous shells were found in a crevice (e.g., see UXO 38 or UXO 39). Ordnance were generally loose and varied in condition from whole unexploded shells to ones that were broken open. In some crevices, along with the ordnance were 1 lb. fishing weights. This area is just inside the Piti Bay Marine Protected Area (MPA) and is often poached by fisherman standing on the outfall pipe, which serves as the eastern boundary of the MPA.

Ordnance in deeper water (between 10-40 m) do not appear to have spread laterally along the reef slope since 1978 (Figure 3). The Department of Navy found the highest concentrations of ordnance in zones B & C, which matches the results reported here. Ordnance were not present in zone D in 1978 and do not appear to have spread into that reef area at this time as no ordnance were found east of UXO 22. Due to hazardous conditions, the western extent of the ordnance was not adequately defined in this survey, but National Park Service divers have conducted extensive work between 10-20 meters north and west of Camel Rock and have never previously encounter ordnance in this area.

Figure 3. Locations of UXO found on the reef slope near Camel Rock. Areas A-D correspond to zones surveyed by the Department of Navy (1978). Hatched points (UXO 21, UXO 23, UXO 25, and UXO 35) are sites where no UXO were located.
