## **Use of Military Demolition Explosives in a Remediation Project**

Michael R. Walsh, Charles M. Collins, Michael T. Meeks,  
Alvin O. Lee, and Eric G. Wahlgren

October 2003

Prepared for      U.S. ARMY ENVIRONMENTAL CENTER  
                         and  
                         U.S. ARMY ALASKA

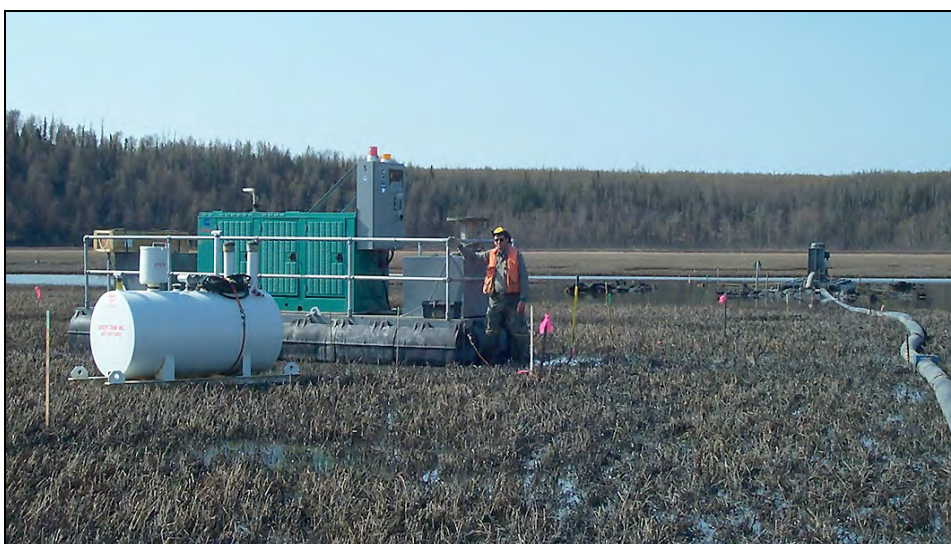
**Figure 2. Pump system deployed at ERF.**

The second pond treatment method involves temporary pond draining using a large-capacity pump. The pump removes the water from the ponded area, quickly removing the habitat from use by dabbling waterfowl and allowing the sediments to dry and the remediation process to initiate (Fig. 2). The pumping has to be repeated periodically, either as the basin starts to refill from surface water and groundwater inflow from the surrounding areas, after a rain event, or during one of the periodic flooding high tides. The greatest advantage of temporary pond draining is that it is easily reversible. After the pond bottom sediments dry sufficiently to sublime and oxidize the white phosphorus, the pond environment can be restored by removing the pump and allowing the natural periodic flooding tides to refill the pond basin and restore the aquatic and emergent vegetation. An autonomous pumping system consisting of a float-mounted centrifugal pump and a separate float-mounted generator set (genset) connected by power and control cables was designed and built for testing purposes in 1995 (Collins et al. 1996, Walsh et al. 1999b, 2000). In the initial planning phase of the project, it became

obvious from the relatively low relief of the shallow ponds that a sump in the middle of the pond is needed for the pumps to operate effectively. Without a sump, the pumps will cycle frequently as the water is repeatedly drained down around the pump. In addition, shallow drainage ditches are needed to connect scattered low points in the pond area to the sump. Ditches are also useful in treating adjacent contaminated ponds without the need of additional pump systems and sumps. All this needs to be accomplished with minimum human exposure to unexploded ordnance (UXO).

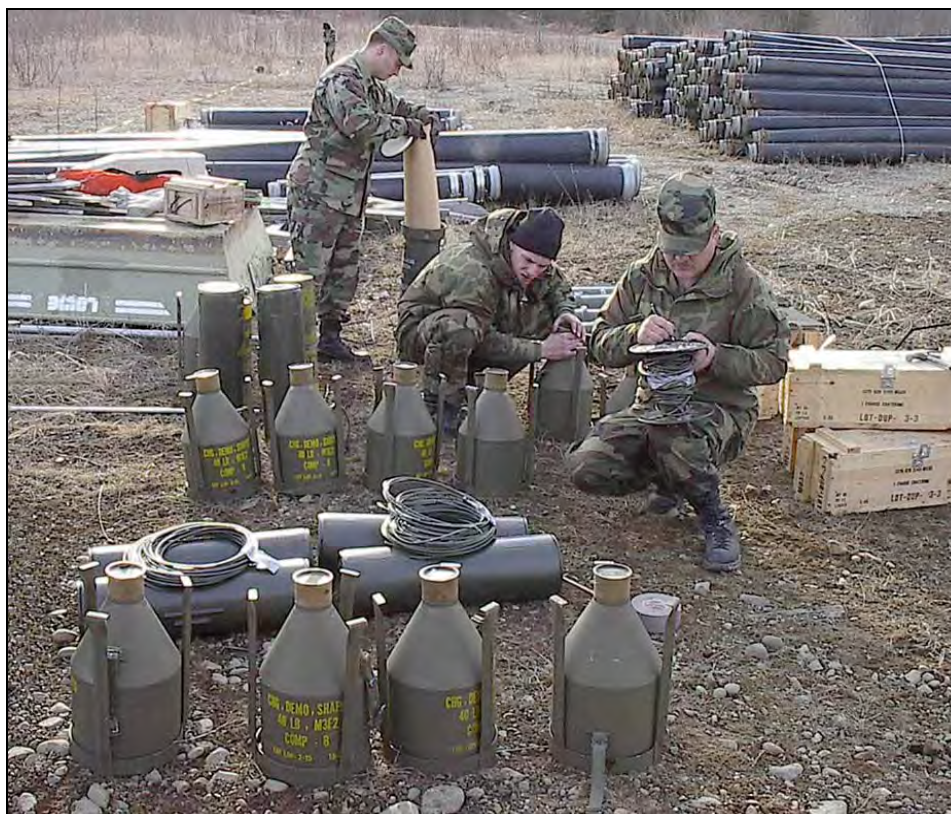
**Figure 4. Preparation of shaped (foreground) and cratering charges.**

The Bread Truck ditch was excavated in two stages (Fig. 4). The first stage used seventeen 18-kg shaped charges to explosively form boreholes into the sediment. The charges were spaced every 5 m along the centerline of the planned ditch. Type 1 M45 line main detonation cord (29.5 g/m, 6.4 lb/1000 ft) connected all seventeen shaped charges together. A dual detonating firing system consisting of two fuse igniters, two lengths of time fuse cut to 7-minute lengths, and two blasting caps was used. When detonated, the shaped charge produces a plasma jet that will punch a 30-cm-diameter hole straight down into the ground. The total

amount of explosives detonated in this first explosion was approximately 320 kg (700 lb). Following a sweep of the area for UXOs, the second stage of the explosive excavation was set up. An 18-kg cratering charge was placed in each of the boreholes created by the shaped charges. The charges were wired together in a similar manner to the shaped charges. One or more sandbags were placed in most of the boreholes on top of the cratering charges. The number and way the sandbags were placed varied from hole to hole, depending on the soldier who did the placement. Since all the boreholes were filled with water from the pond, it was difficult to determine how effective the sandbags were in tamping the underlying charge.

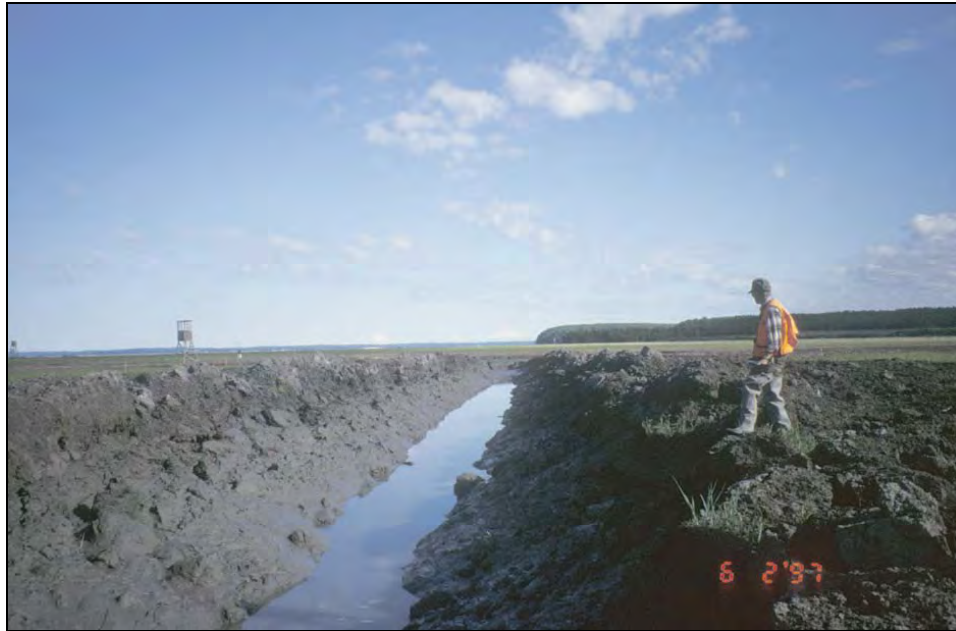
**Figure 6. Drainage ditch at Pond 293 (cratering charges).**

The detonation of all forty cratering charges produced a large explosion that threw material several hundred meters into the air. The explosion formed a nearly straight 120-m-long ditch, 2 m deep and 4.7–5 m wide, leading from the pond to the gully (Fig. 6). The problems encountered the previous year with the Pond 109 ditch with various sizes of craters and with some craters not overlapping were completely avoided. The closer spacing of cratering charges and the tamping of the boreholes containing the cratering charges with sandbags produced a more constrained explosion and a more consistent lateral excavation of ground material. Immediately following the blast, water started flowing into the newly excavated ditch from Pond 293. The first crater at the north end of the ditch was a

meter and a half deeper than the pond where it was located, resulting in a cascade of water down into the crater. Water continued to flow into and fill the ditch for about twenty minutes. After the ditch filled with water, it began to erode the berm thrown up around the last crater at the end of the ditch and flow out of the south end of ditch into the ice-filled gully and hence into the river. Water continued to flow out of Pond 293 and the surrounding sedge marsh for several weeks until the area drained.

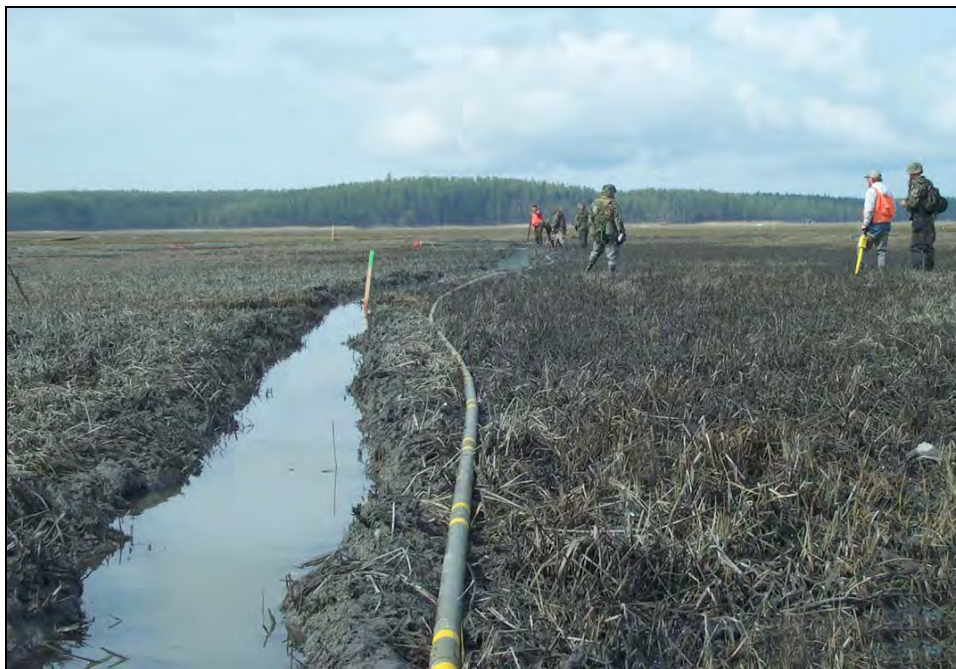
**Figure 7. Laying out Bangalore torpedoes.**

cratering charges to lessen the impact. Bangalore torpedoes are cylindrical demolition charges 1.52 m in length and 54 mm in diameter. The primary explosive component is Comp B4 (4.76 kg), with a 0.46-kg Comp A3 booster (U.S. Army 1998). The M1A2 Bangalore kit consists of 10 sections of torpedoes that can be assembled end-to-end using supplied sleeves to create a line charge. Any number of Bangalores can be assembled in this manner. The line charges used for ditching Pond 285 were initiated using M45 Type 1 detonation cord, a time fuse, and blasting caps placed in the detonator well of the Bangalore. Tests conducted in terrain in the Flats similar to that to be encountered between Pond 285 and the south channel of the Eagle River indicated that Bangalores placed on or cut slightly into the unfrozen surface of the sedge meadow characteristic of this area will create a ditch approximately 1 m wide by 70 cm deep.

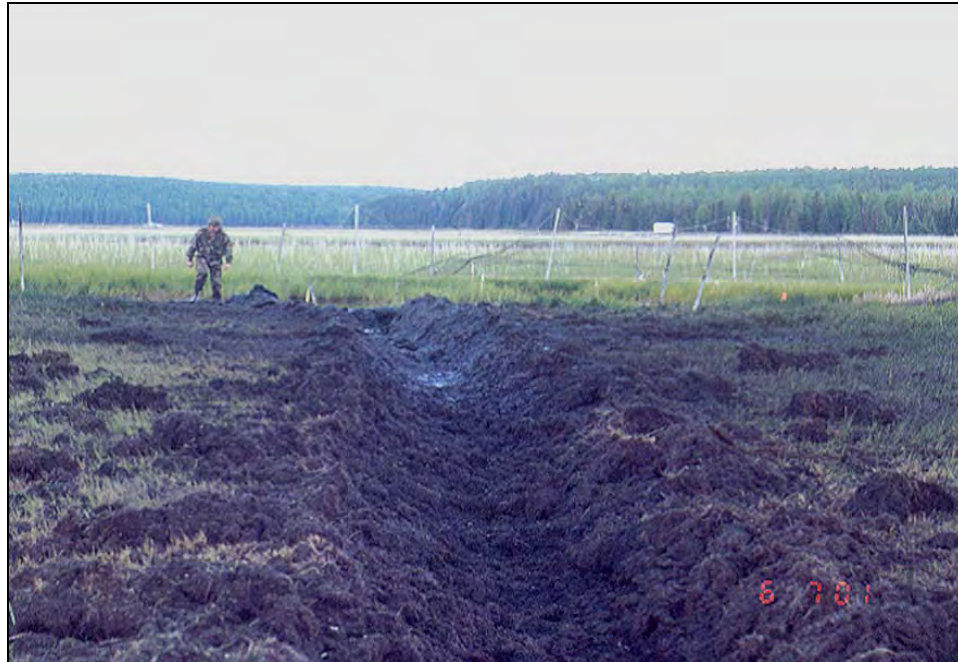
**Figure 8. Drainage ditch at Pond 285 (Bangalores).**

To form the ditch to drain Pond 285, a 46-m-long string of Bangalore torpedoes was laid from the edge of the central area of the pond, across the higher vegetated levee area, to the right channel of the Eagle River (Fig. 7). The final 4 m of Bangalores was cut 15–20 cm into the levee to deepen the ditch. At the pond end, two sections of five-stranded Type-1 detonation cord were used to branch into the two arms of the pond. The detonation of the Bangalores formed a ditch approximately 55 cm deep by 1 m wide (Fig. 8). Water drained into the ditch after breaking down the ejecta rim at the pond end, but it was evident that

because of the higher ground of the levee next to the river, the river end of the ditch was not deep enough to allow effective drainage. An additional 12 sections of Bangalores (18 m) were used at the river end to further lower this end of the ditch for drainage into the river. The ditch is large enough to effectively drain the pond yet small enough to allow easy restoration of the pond if necessary.

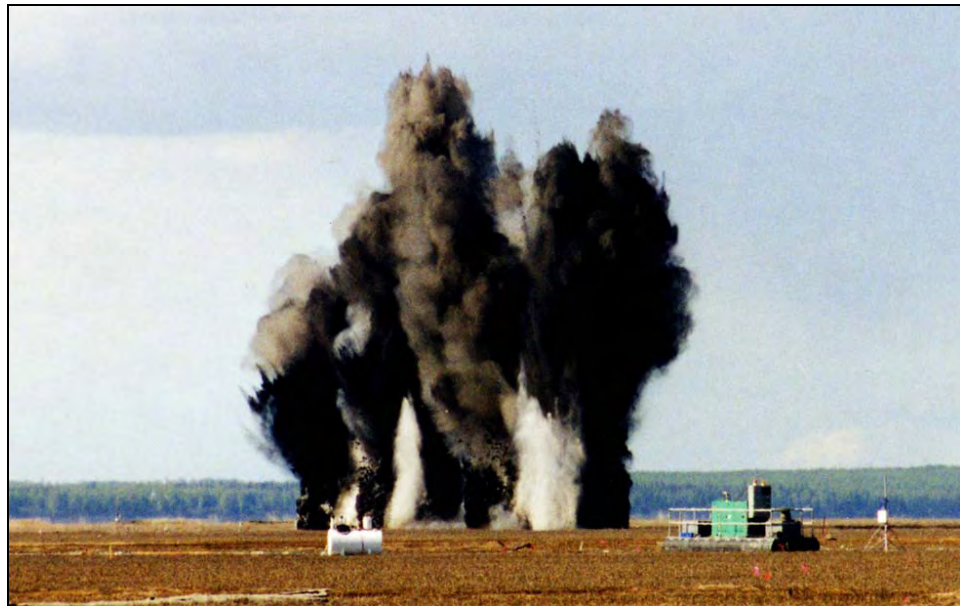
**Figure 10. Blasting a sump drainage ditch with Bangalore torpedoes and det cord.**

enhances its effectiveness. Recently, we have found that doubling up the detonation cord (10-strand) and inserting it in precut slots in the areas where previously only Bangalores would work, such as heavily vegetated areas will form a sufficient drainage ditch. This allows ditching through difficult materials to be conducted closer to sensitive equipment without the concussion caused by the much larger Bangalores. Ditching to sumps is now done almost exclusively with det cord.

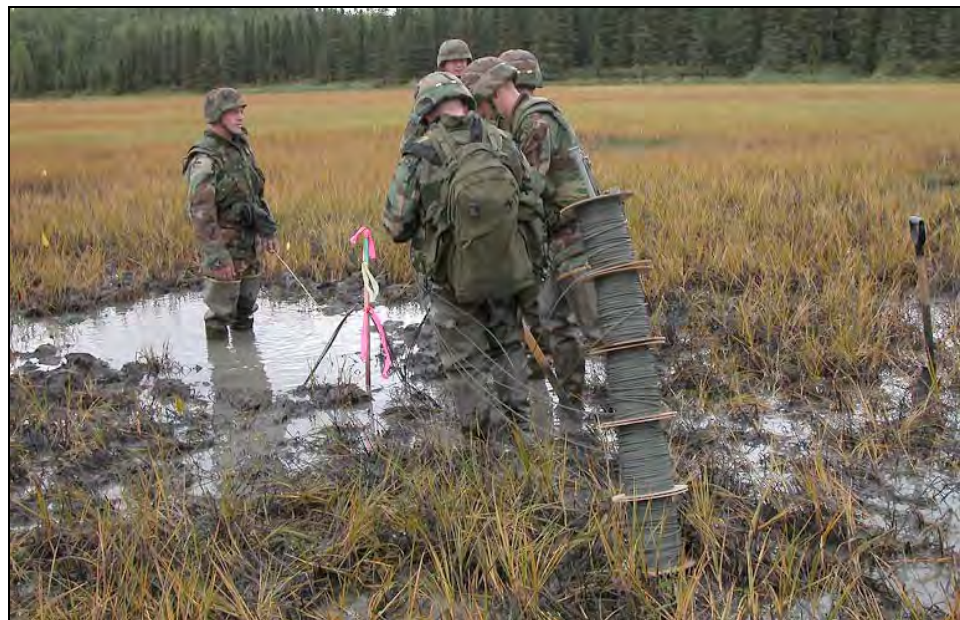
**Figure 11. Field assembly of a five-strand det cord run.**

It is important that the det cord be pre-bundled. Bundling in the field has resulted in inconsistencies in the number of strands used (one to six) as well as long set-up times. Twisting of the det cord is also crucial to ensure that the bundle stays intact when pressed into the ground. Separation of the strands results in ineffectual excavation of the ditch. Ty-wraps alone are not sufficient, as the strands will separate when tamped. Although tamping by foot is not recommended in FM 5-250, we have not had problems with misfires due to internal cracking of the cord. This may be due to the multistrand make-up of the line.
